***Site 006 Track 1 Decision Documentation  
Package, OU 10-08***

**Site Description: Cistern North of NRF**

**Site ID: 006**

**Operable Unit: 10-08**

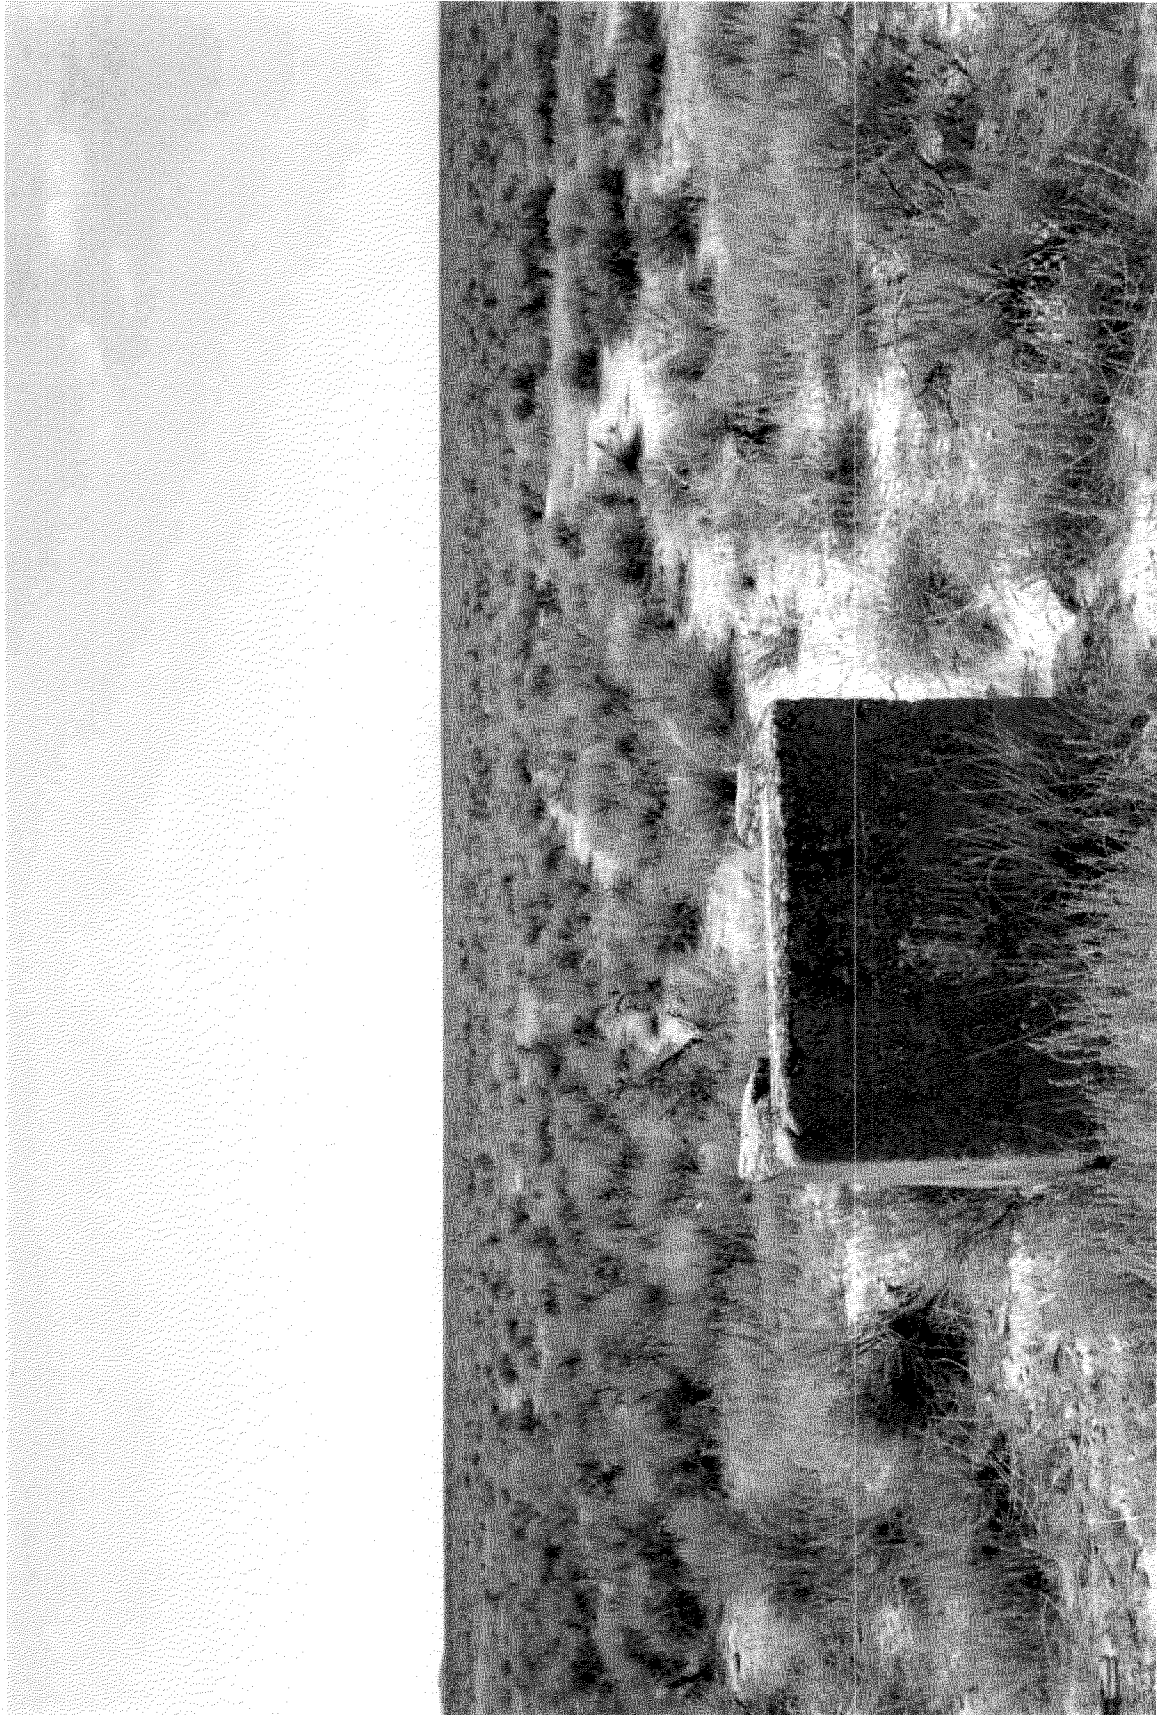
Site: 006, Cistern North of NRF  
(PN94-0778-2-6A)

Site investigation and photographs indicate that the cistern is located approximately 2 ft above ground level with a base dimension of 10-12 ft. The liquid appears to be at least ~1 ft deep. The cistern is estimated to hold 2,000 gallons of liquid. Based on pH sample and visual evidence, there is no indication that a source is present at this site.
